#### **TECHNICAL REPORT ARCCB-TR-98020**

# COMPREHENSIVE EROSION MODEL FOR THE 120-MM M256/M829 GUN SYSTEM

#### **DECEMBER 1998**

# US ARMY ARMAMENT RESEARCH, DEVELOPMENT AND ENGINEERING CENTER

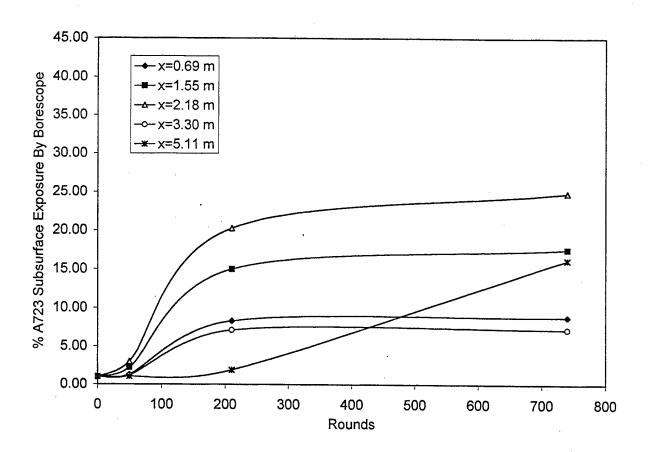
Figure 4 summarizes the M829 borescope data analysis of the A723 subsurface exposure through HC chromium plate cracks as a function of rounds fired for selected axial positions. The experimental borescope data was used to calibrate the erosion analysis. This data was collected on a cleaned M256 tube that had mostly M829 rounds. These M829 rounds consisted of a nearly equal distribution of hot/ambient/cold temperature conditioning. Data collection involved the use of a magnifying borescope with a calibrated scale to measure the number and average area of each HC chromium platelet within a designated total area as a function of axial position for a given round count.

We were able to collect high quality borescope data on a single M256 tube with mostly M829 rounds near its 50-round point, near its 200-round point, and at its final out-of-service round point. The balance of the non-M829 rounds was converted to effective M829 rounds. The initial zero-round condition data were not collected from this M256 tube, but from the many unfired M256 tubes available at Watervliet Arsenal. High contraction chromium plate has fine cracking and finite shrinkage when manufactured and prior to firing. We recognize that this is a sample of one and that significant variability exists depending on combinations of round count, round type, round-conditioning temperature, and their firing order.

For the selected axial positions in Figure 4, from 50 to 150 rounds, A723 subsurface exposure rose rapidly due to HC chromium thermal repacking, nonmetallic out-gassing, and possibly compression resulting in its shrinkage and heat checking. After about 150 rounds, the above mechanism diminished and the A723 subsurface exposure rose more slowly because only the HC chromium platelet spalling mechanism remained. At the 5.11 meter from RFT near-muzzle position, the A723 subsurface exposure rose very rapidly from about 150 rounds until its out-of-service round count due to HC chromium platelet spalling by a different purely mechanical mechanism. This tube was condemned due to fatigue at its full fatigue life.

Figure 4. M829 borescope data analysis of the A723 subsurface exposure through HC chromium plate cracks.

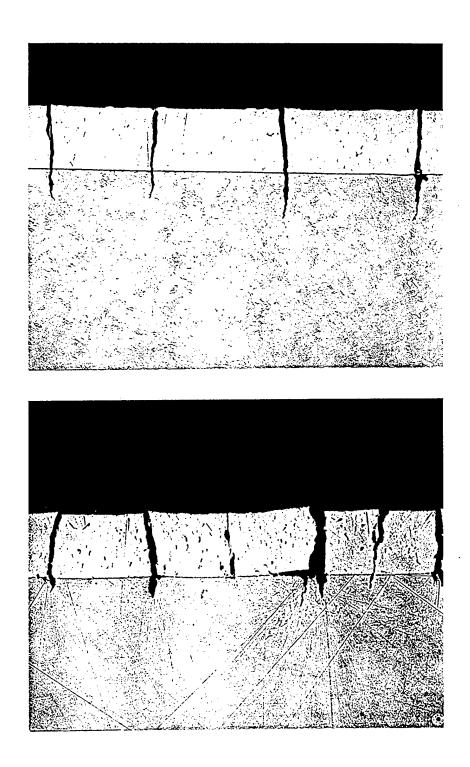
Figure 5 (top) presents a typical 100x metallograph of an M256 tube with mostly M829 rounds at 0.69 meter from RFT. This represents the 0.6 to 1.2 meter region and was used to calibrate the erosion analysis. The 0.6 to 1.2 meter region has the highest gas pressure of any bore region (Figure 1), which explains the deep crack depths due to severe dilation. Although this 0.6 to 1.2 meter region has the highest gas temperature of any bore region (Figure 1), heat transfer to the wall is significantly diminished due to combustion case gas cooling effects (Figure 2). These observations explain the heat checking and crack spacing as well as the near absence of interface degradation and chromium platelet spalling.

Figure 5 (bottom) presents a typical 100x metallograph of an M256 tube with mostly M829 rounds at 1.55 meters from RFT. This represents the 1.2 to 2.4 meter region and was also used to calibrate the erosion analysis. The 1.2 to 2.4 meter region has a lower gas pressure than the 0.6 to 1.2 meter region (Figure 1), which explains the moderate crack depths due to moderate dilation. Although this 1.2 to 2.4 meter region has a lower gas temperature than the 0.6 to 1.2 meter bore region (Figure 1), heat transfer to the wall is significantly higher due to turbulent gas mixing (Figure 2). These observations explain the heat checking and crack spacing as well as the noticeable interface degradation and mild chromium platelet spalling. We theorize that the main gun erosion mechanism consists of inert chromium plate cracking, shrinkage, and heat checking, followed by subsequent interfacial degradation of the subsurface gun steel substrate at the chromium crack bases, subsequent chromium platelet spalling, and subsequent bare gun steel gas wash. The gun steel at the chromium/gun steel interface is more susceptible to interface degradation than either of its components separately due to its higher energy state and reactivity. In addition, interface degradation is enhanced by expansive flaking of iron oxide.

As chromium platelets detach from the substrate and rise above attached chromium platelets, they are more susceptible to mechanical removal by the projectile. In addition, the 1.2 to 2.4 meter region has a wavy chromium surface appearance in cross-section due to partially detached chromium platelets. Rarely do radial heat-checking cracks link-up to spall a chromium platelet with attached gun steel. Although there appears to be evidence of heat-checking cracks extending into the wall well beyond the heat-affected zone due to environmental-assisted cracking, great scrutiny has produced no measurable evidence of chromium platelet spalling due to cracking in the plane of the chromium plate/gun steel interface.

Figure 5. M829 metallographs at 0.69 meter representing 0.6 to 1.2 meter region (top) and at 1.55 meters representing 1.2 to 2.4 meter region (bottom).
